Northeast Aquatic Research

Lake Zoar Pre- and Post- Aquatic Plant Treatment Survey Results for 2017

Pre-treatment Survey: partial survey conducted on June 7th, 2017.

Treatment Dates: June 15th and August 24th, 2017. Target plants: Eurasian milfoil, Curly-leaf pondweed, and spiny naiad.

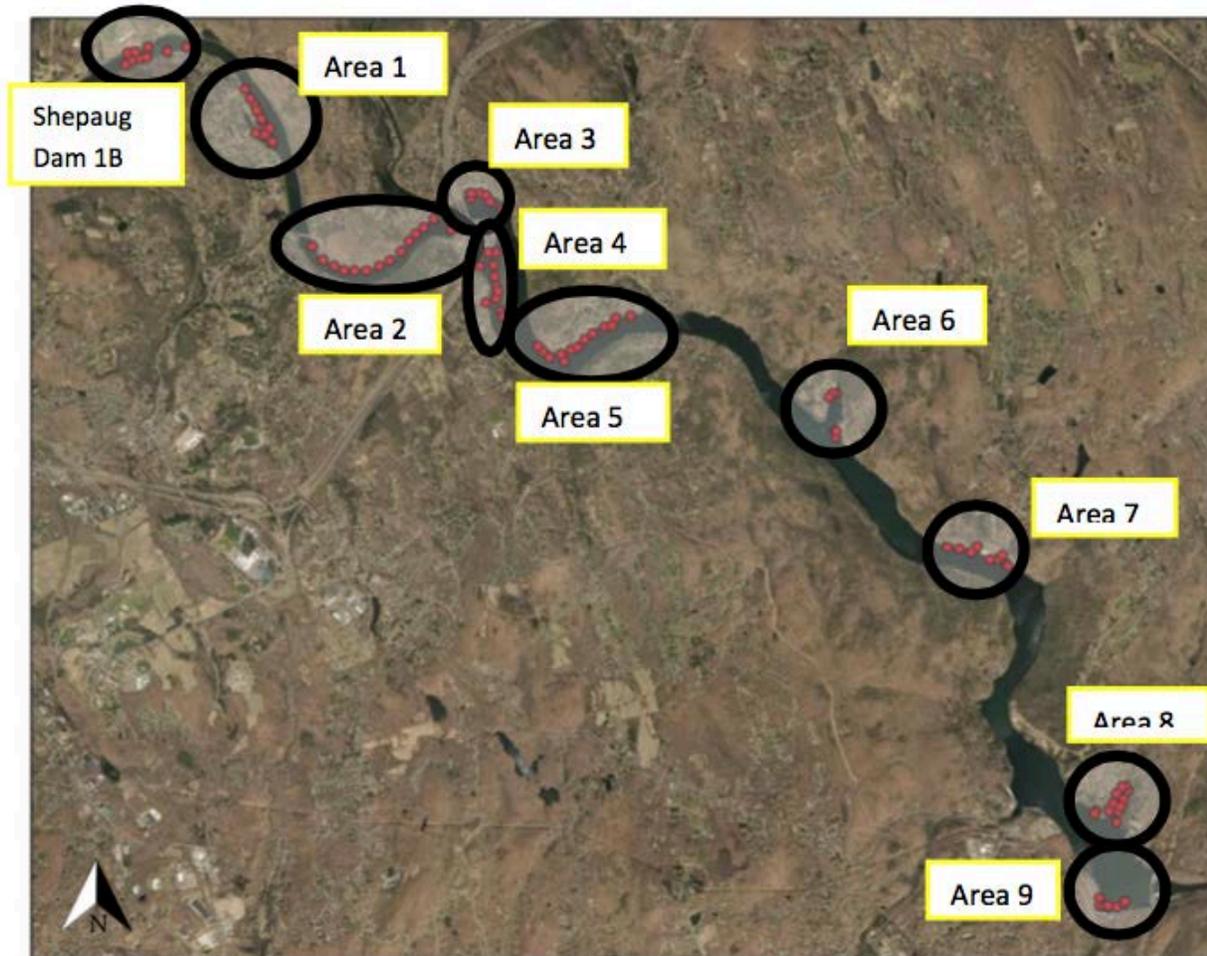
Map 1 - Overview of All Sites

Area	Size (acres)	Location - Description
1B	5.9	Narrow bands 100 feet wide opposite each other along the eastern and western shorelines.
1	10.0	Narrow band 100 feet wide along western side and within small cove about 1 mile below the Shepaug Dam.
2	5.7	Narrow band 70 feet wide along eastern shore about 2.5 miles below Shepaug Dam. Includes small bed on western side immediately above I84 Bridge.
3	8.2	Large bay on eastern side immediately below I84 Bridge, bounded to the west by large sandbar.
4	14.4	Large area that includes both sides of central sandbar and shallow waters on the western side.
5	11.2	Large shallow area offshore of DEEP boat launch and narrow band 75 wide along eastern shore.
6	5.0	Inner end of cove at Kettletown State Park.
7	2.4	Two small coves on eastern shore at Jackson Cove State Park.
8	8.4	Narrow band 50 feet wide and cove on eastern side about 2.5 miles above Stevenson Dam.
9	3.2	Small bay on western side about 1000 feet above Stevenson Dam.

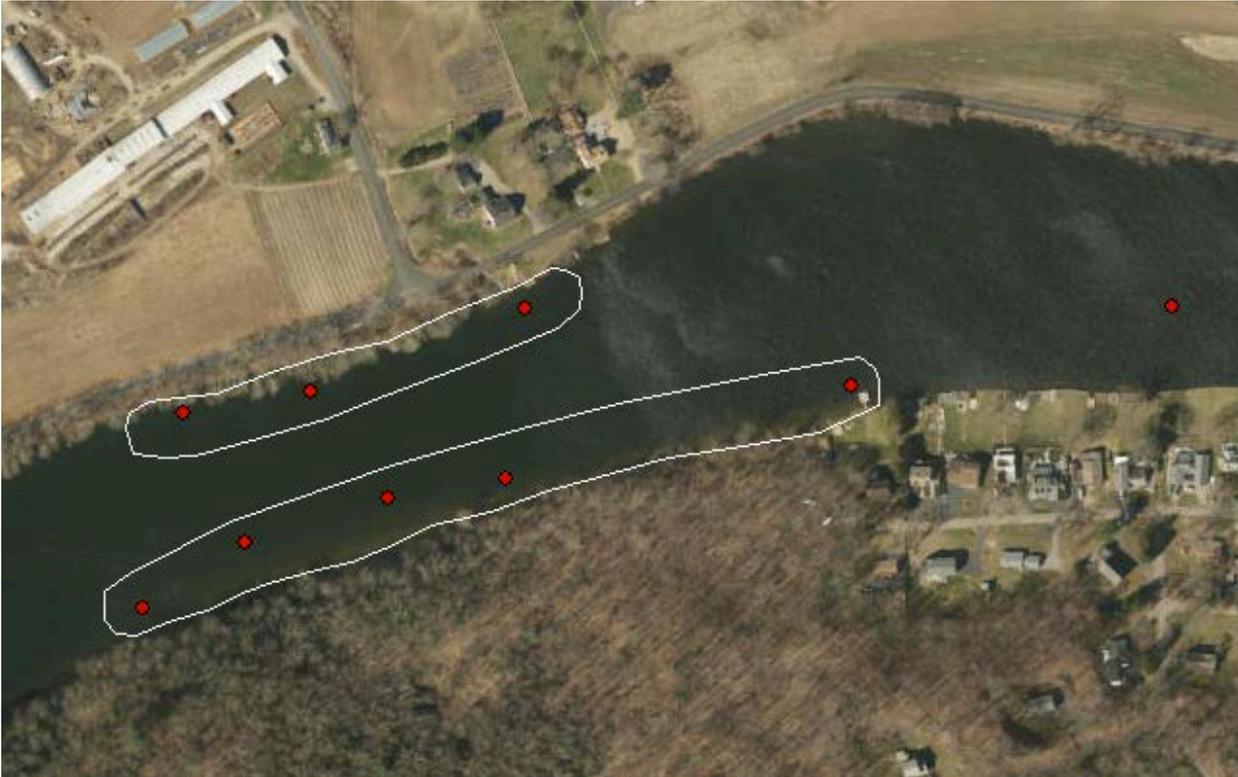
Map 2 - Treatment Area 1B

Milfoil was growing in a band along the western shoreline, becoming denser closer to the dam. No milfoil was present in the treatment area along the eastern shoreline. No other species were found in this area.

First post-treatment: Dense milfoil covered most of this area in a long band along the shoreline. Curly leaf pondweed was found at one waypoint but at a low density. No spiny naiad was found in this treatment area. Tape grass and aquatic moss were also found at one waypoint each in this area.

Second post-treatment: Milfoil remained dense along the shoreline in this area. Tape grass expanded slightly, present at 50% of waypoints at a relatively high density. Water stargrass and sago pondweed were also present at one waypoint each. No curly leaf pondweed or spiny naiad was found in this treatment area.

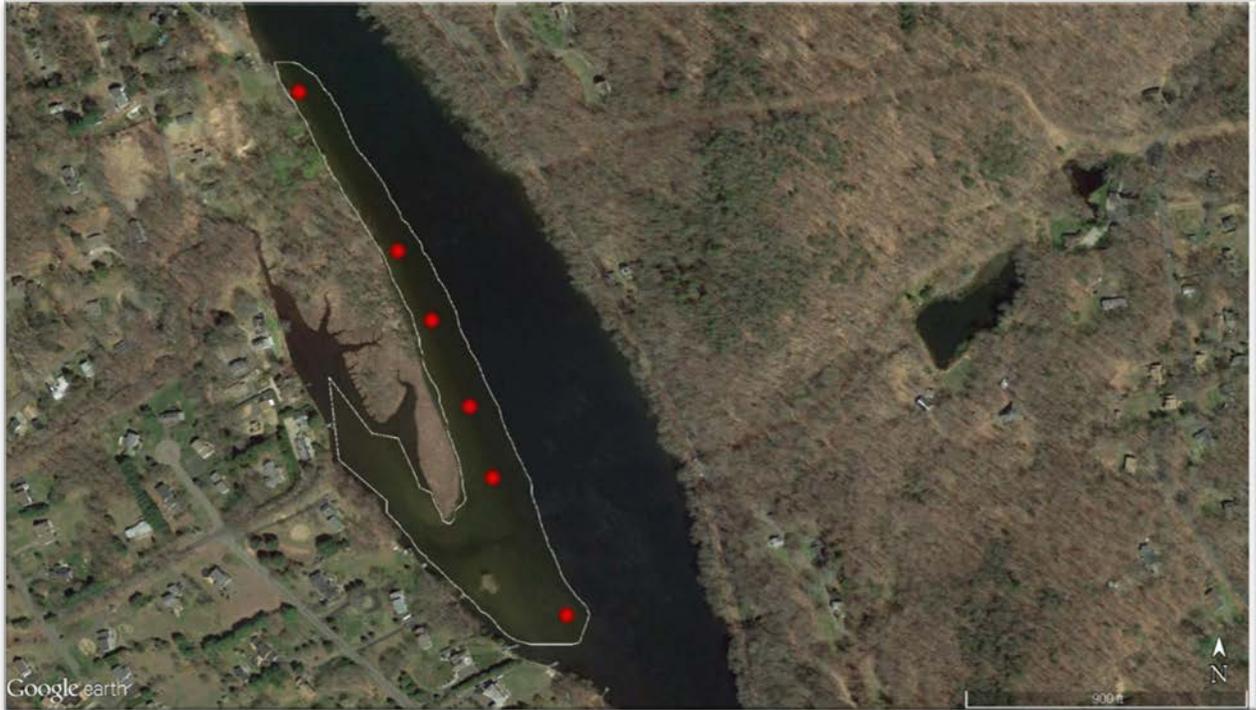
Map 3 - Treatment Area 1

Milfoil filled this treatment area, present at 100% of the waypoints. The milfoil was dense at most waypoints, although a few waypoints exhibited a medium or low density. Curly-leaf pondweed was present in approximately half of the area, mostly at a low density. The only other species found in this area was water stargrass, which was found at one waypoint.

Post-treatment: Milfoil decreased to half of the waypoints in Area 1, growing in moderate to dense patches. Curly leaf pondweed was found at two waypoints, but was very sparse. Tape grass, ceratophyllum demersum, and water stargrass and western waterweed were also found at a moderate density in this area. Spiny naiad was not found in Area 1.

Second post-treatment: Milfoil remained dense and present in approximately 50% of the treatment area. Tape grass expanded to nearly 90% of the treatment area at a high density and coontail and western waterweed were also dominant at a medium density. Water stargrass, aquatic moss, long-leaf pondweed and clasping-leaf pondweed were each present at one waypoint. No spiny naiad or curly-leaf pondweed was found in this area.

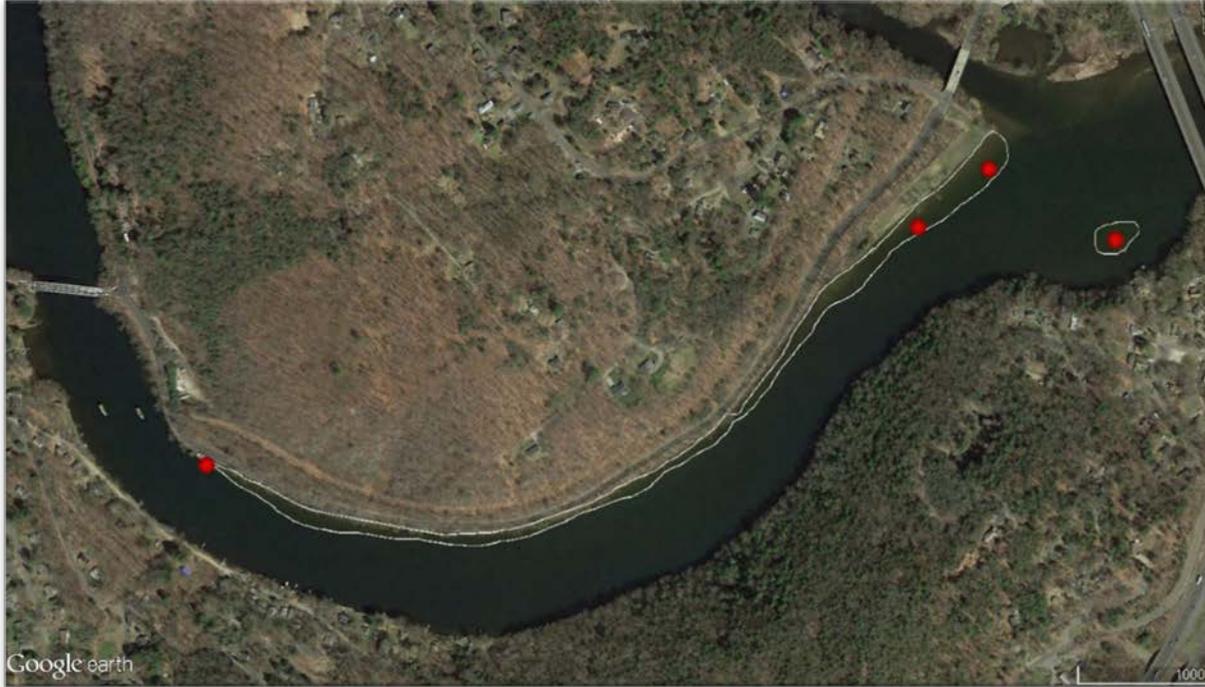
Map 3 - Treatment Area 2

Eurasian milfoil filled this treatment area. While the majority of the milfoil in this area was dense, a small portion of the shoreline had milfoil growing at a low to moderate density. Curly-leaf pondweed was present at approximately 40% of the waypoints at a low density. Coontail was also found at a low density at one waypoint.

Coontail, tape grass, and Eurasian milfoil dominated the treatment area. After the herbicide treatment, milfoil decreased to 50% of waypoints. It was sparse in most of the area but two patches were dense. No curly-leaf pondweed or spiny naiad was found in this treatment area. Several other native species were present at varying densities.

Milfoil was present at the same frequency and density as the first post-treatment survey. Spiny naiad was also found at two waypoints at a low density during this survey. Tape grass, coontail and water stargrass remained dominant and had spread since the first post-treatment survey. Waterweed, aquatic moss, sago pondweed, claspingleaf pondweed and small pondweed were each found at one waypoint each at a low density.

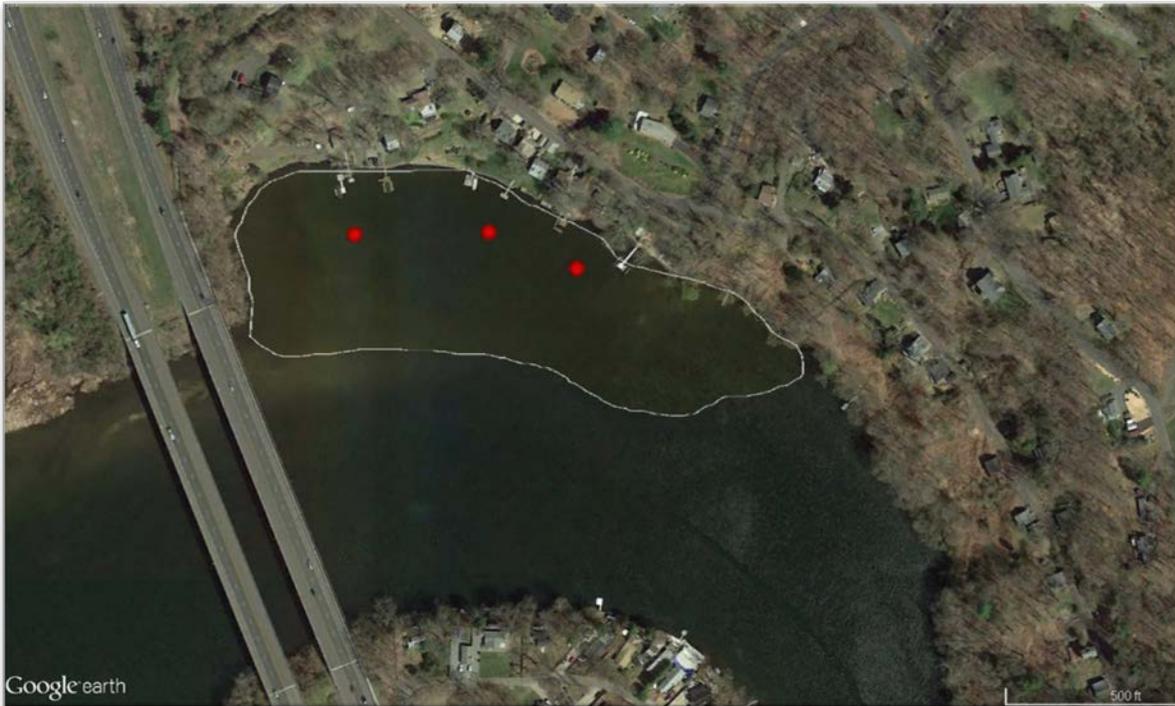
Map 4 - Treatment Area 3

This treatment area had dense (100% cover) Eurasian milfoil at nearly 70% of waypoints. Curly-leaf pondweed was present in 50% of the area, at a high density at two waypoints. Western waterweed was present in nearly 70% of the area, but at a very low density.

Only four species were present in this area and all four species were dominant, present at more than 20% occurrence. The milfoil patches did not decrease in size after the treatment but the patches did become less dense. Tape grass, water stargrass, and coontail were also dominant species. No spiny naiad or curly-leaf pondweed was found in this area.

Tape grass was present at all the waypoints in this treatment area, growing at a medium density. The only other species were coontail and small pondweed, each present at one waypoint at a low density. No invasive species were found in the area during this survey.

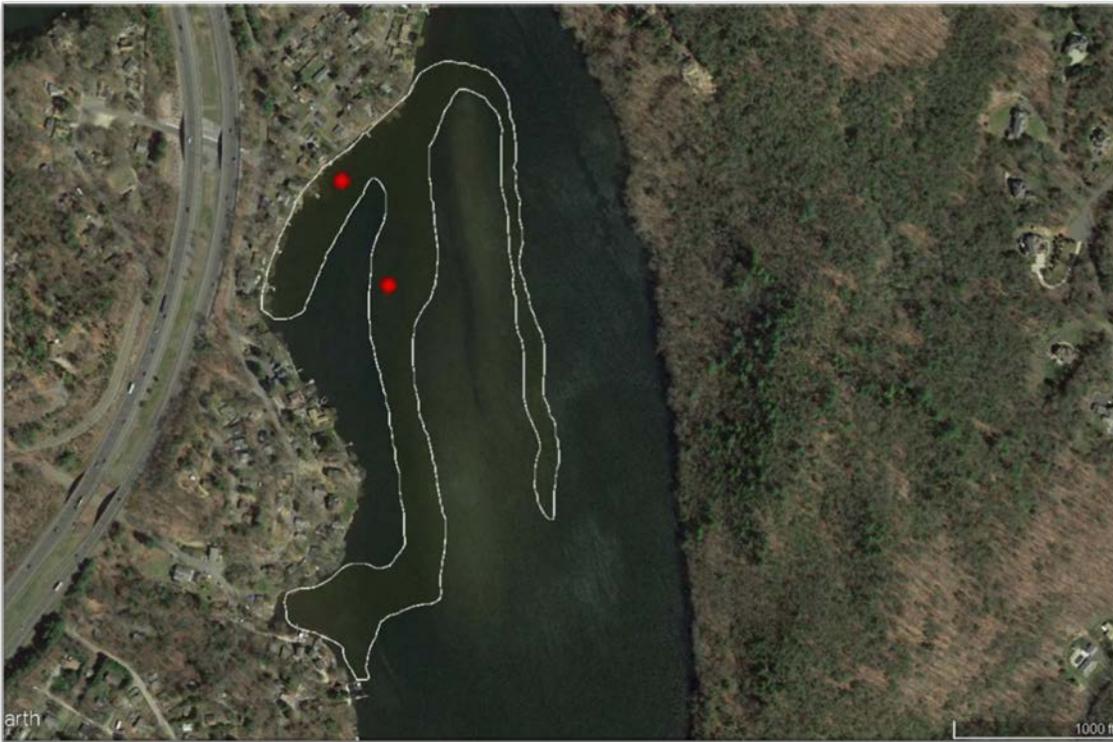
Map 5 - Treatment Areas 4

Pre-treatment: Eurasian milfoil was present at all waypoints in this treatment area. The milfoil was growing at 50-100% cover at most waypoints although one waypoint had just one plant. Curly-leaf pondweed and coontail were each found at two waypoints at a low density.

Milfoil, tape grass, and *Potamogeton bicupulatus* were the dominant species in this area. The herbicide treatment successfully decreased milfoil in this area. During the post treatment survey, it was present at approximately 60% frequency and 30% average density. Curly leaf pondweed was present at one waypoint but was very sparse. Coontail, water stargrass and elodea were also present. No spiny naiad was found in this area.

Tape grass and coontail both spread since the first post-treatment survey. Tape grass was present at all but one waypoint at a moderate density and coontail was present at 60% frequency and approximately 25% average density. Curly-leaf pondweed also remained present at one waypoint at a low density. Elodea, aquatic moss, and clasping-leaf pondweed were each present at one or two waypoints. No invasive species were found in the area during this survey.

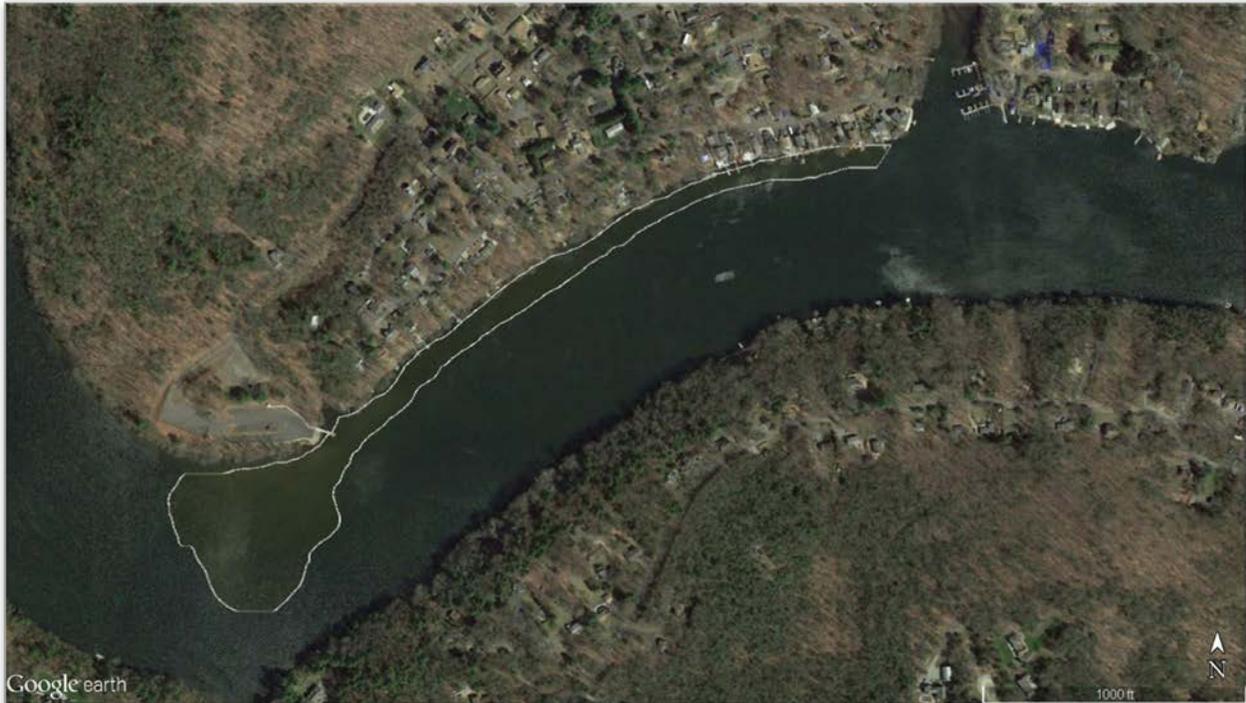
Map 6 - Treatment Area 5

Pre-treatment: Curly-leaf pondweed was found at 100% of waypoints in this treatment area, mainly at a medium to high density. Milfoil was growing at a medium density in the upstream half of the treatment area. No milfoil was found in the downstream portion. Tape grass and coontail were each found at one waypoint at a low density.

Eurasian milfoil, tape grass, coontail, and snail-seed pondweed were all dominant species in Area 5. The Eurasian milfoil was present at a similar frequency in both the pre- and post-treatment surveys, but the milfoil was less dense during the post-treatment survey. The curly-leaf pondweed decreased drastically compared to the pre-treatment survey. However, this decrease was likely natural, rather than a result of the treatment, because curly-leaf pondweed begins to die off by mid summer. No spiny naiad was found in this area.

Tape grass remained dominant after the second treatment, present at all but one waypoint. The only other species found in this area was clasp-leaf pondweed, present at just one waypoint at a low density. No invasive species were found in this treatment area.

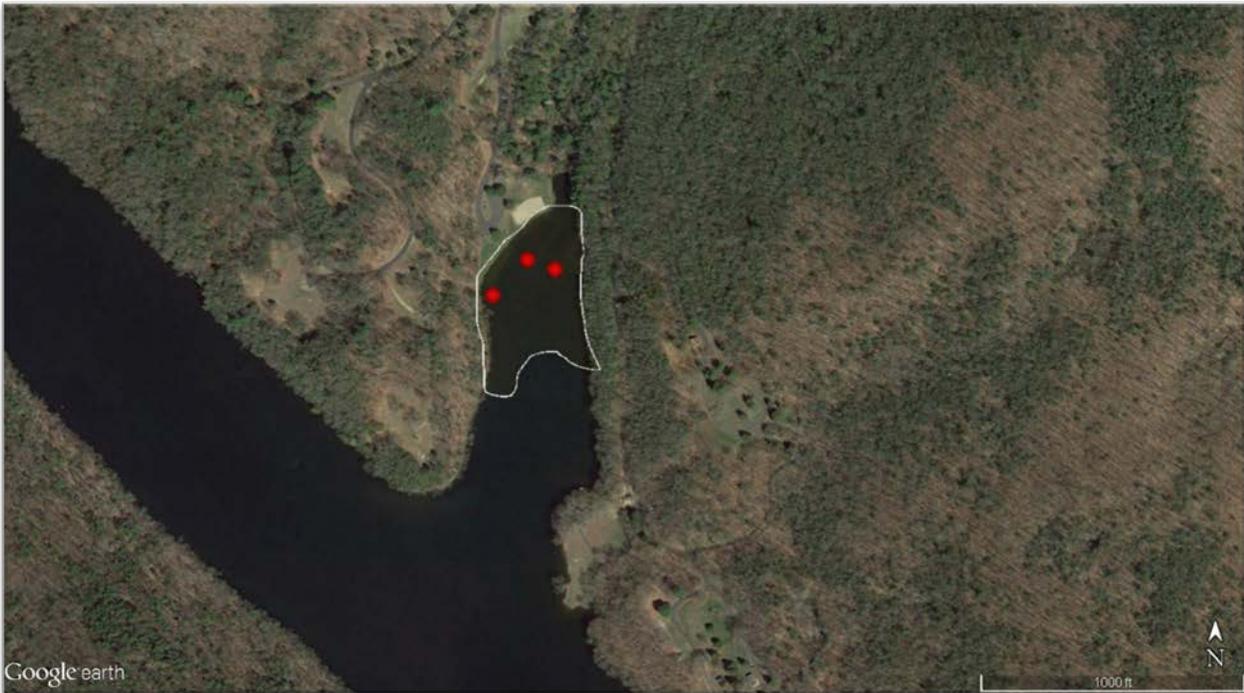
Map 7 - Treatment Area 6

Eurasian milfoil was present in 75% of the cove at a medium to high density. The only other plant found in the cove was curly-leaf pondweed, found at one waypoint at a low density. Consistent with the surveys from recent years, no native species were found in this area.

The herbicide treatment did not appear to significantly reduce the milfoil in this area. Consistent with the findings from the pre-treatment survey, milfoil filled nearly the entire treatment area at a moderate to high density. No other species were present.

Milfoil decreased drastically following the second treatment, with just a few small, newly growing plants found at one waypoint. Coontail, however, had spread in this area, present at all waypoints but remaining at a low density. No other species were found in this treatment area.

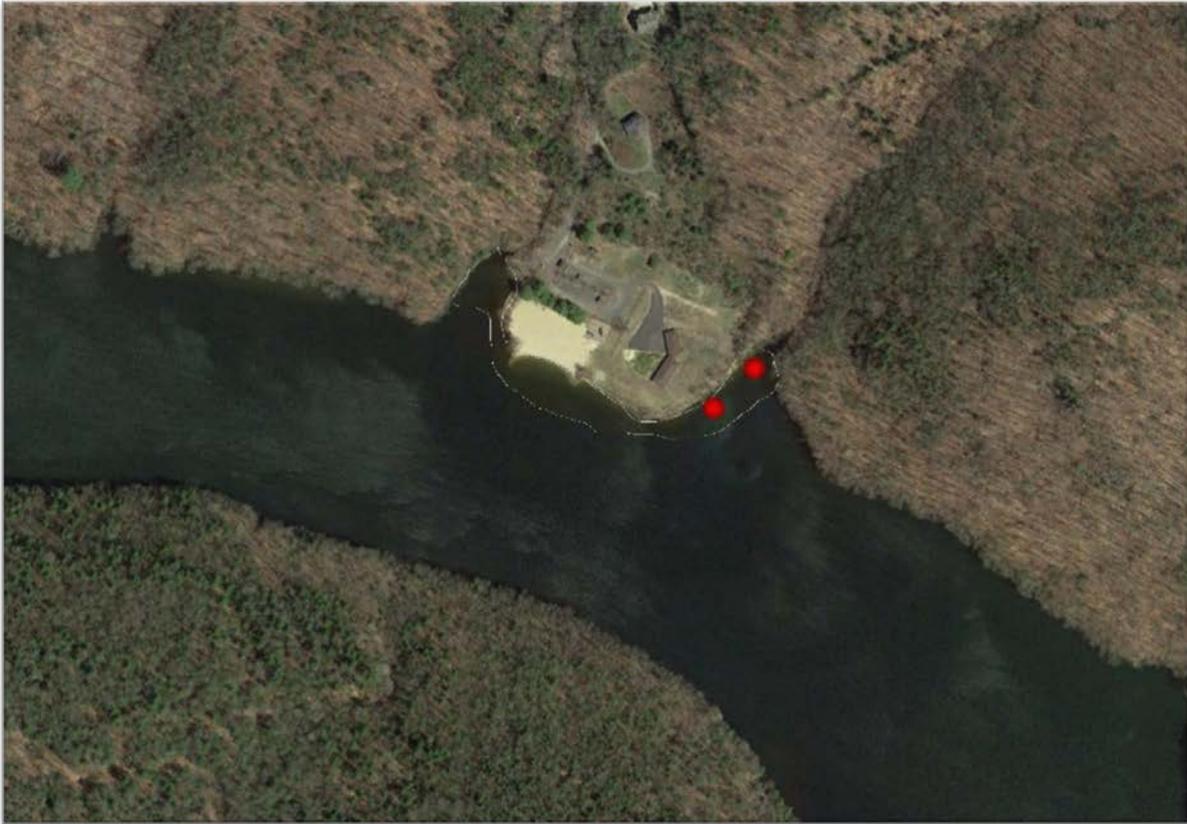
Map 8 - Treatment Area 7

Eurasian milfoil was growing in just under 70% of this area at varying densities, from 15% – 100% cover. Coontail was also present at one waypoint at a low density.

Eurasian milfoil remained present at nearly 90% frequency and was moderately dense, consistent with the findings from the pre-treatment survey. This suggests that the treatment did not successfully reduce milfoil in this area. The only other species found in this area were tape grass and coontail, present at one and two waypoints respectively.

No plants were found in this area following the second herbicide treatment.

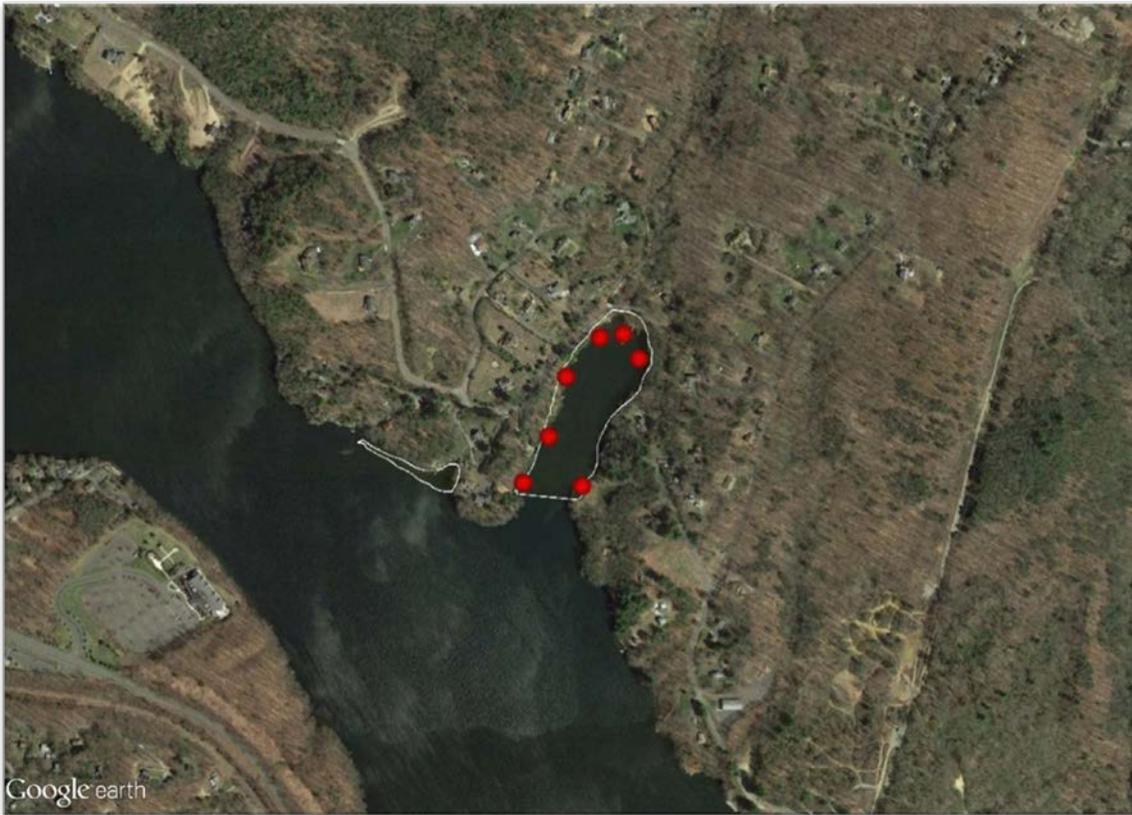
Map 9 - Treatment Area 8

Eurasian milfoil was present in 60% of this treatment area. Overall, the average density of milfoil was lower here (25% cover) than in the other treatment areas. Coontail was also present at two waypoints at a low density. This treatment area appeared to have fewer plants overall compared to the other treatment areas.

Eurasian milfoil was present at over 50% of the waypoints in Area 8 at a moderate to low density, which is similar to the findings from the pre-treatment survey. Coontail was also dominant at this area at a moderate density. Spiny naiad was found at one waypoint, also at a moderate density.

The majority of this treatment area was devoid of any plants. Coontail was present at one waypoint and one dead milfoil plant was found at this same waypoint.

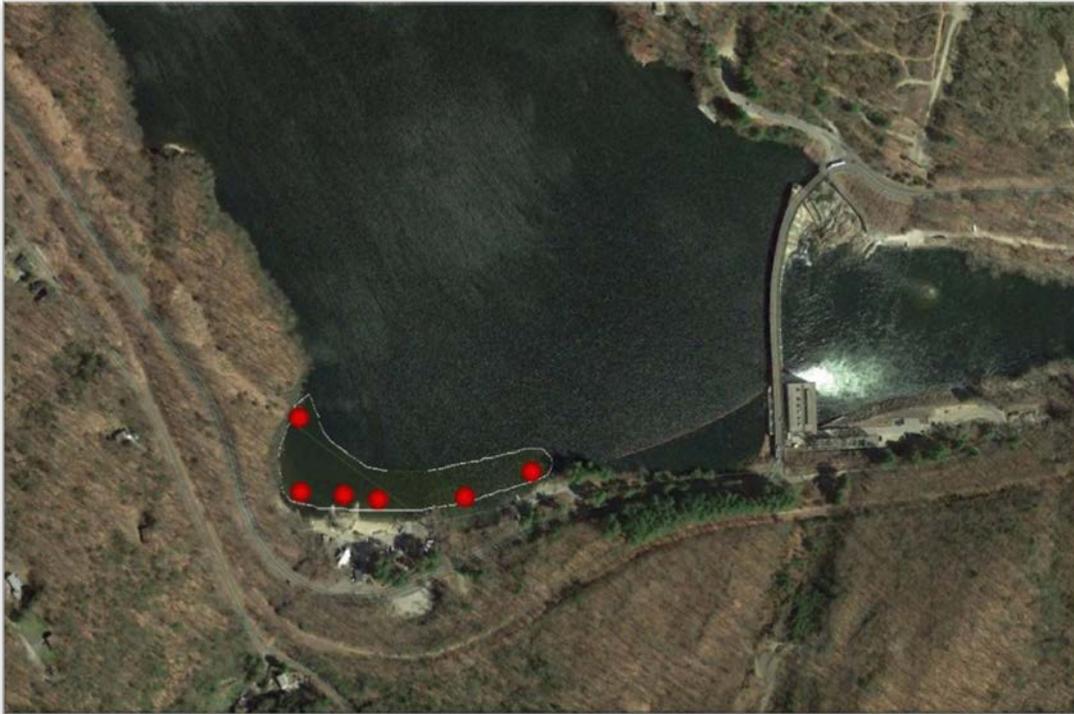
Map 10 - Treatment Area 9

Eurasian milfoil was present at a high density at all but one waypoint in this treatment area. Coontail was also found at one waypoint at a low density. No curly-leaf pondweed was found in this area.

Tape grass, Eurasian milfoil, and ceratophyllum demersum were all dominant in this area at approximately 60% occurrence. The milfoil patches did not appear to decrease significantly in size or density compared to the pre-treatment survey. Spiny naiad, curly-leaf pondweed and water stargrass were also dominant in this area at 25% occurrence but at a low density. No other species were present in this area.

Tapegrass was present at 100% of the waypoints surveyed in this area and was relatively dense. Coontail also remained dominant but was less dense than the first post-treatment survey. One unknown pondweed was found at one waypoint in this area. No invasive species were found in the area during this survey.
