# Northeast Aquatic Research

## Lake Zoar Pre Treatment Survey Results for Survey Conducted on June 3, 2022

**Pre-treatment Survey:** survey conducted on June 3, 2022

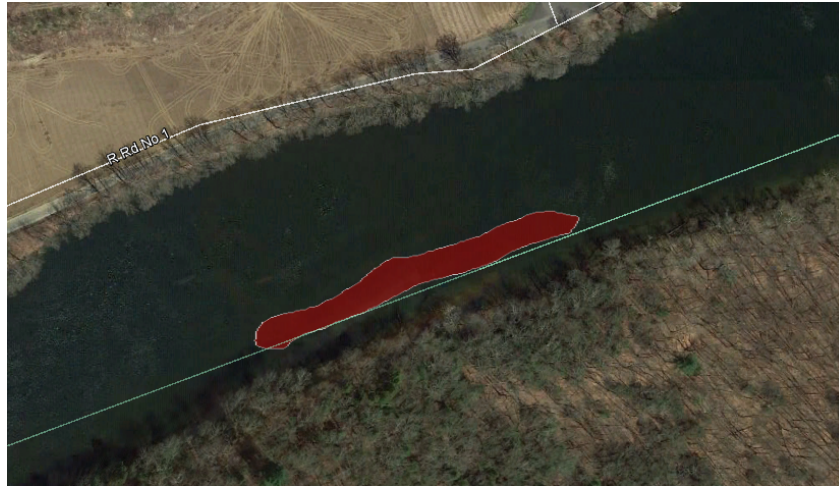
**Map 2: Shepaug Dam New Treatment Area (1b) = 0.7 acres**

**Pre-treatment;** There was minor curly-leaf pondweed and Eurasian milfoil in this area. This area needs to be treated because of the serious risk of infesting to the rest of the lake if allowed to mature.

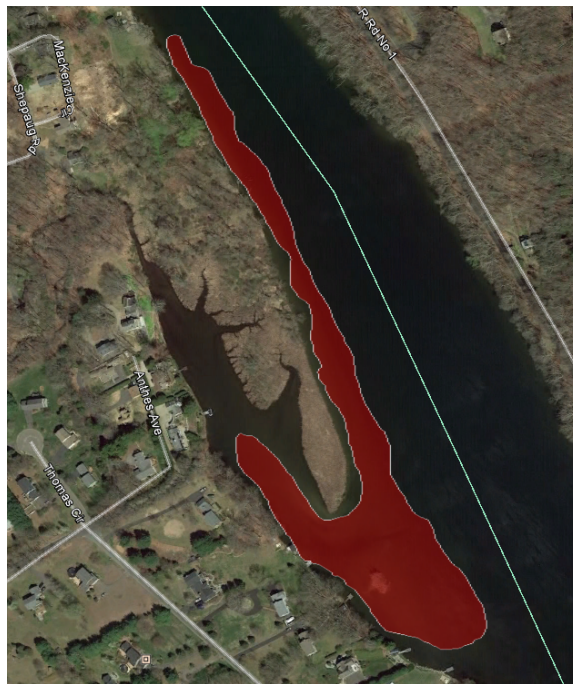
**Map 3: Treatment Area 1 = 6.6 acres**

**Pre-treatment;** This is had a dense to very dense bed of curly-leaf pondweed that was continuous along the shore and within the cove. This area needs to be treated.

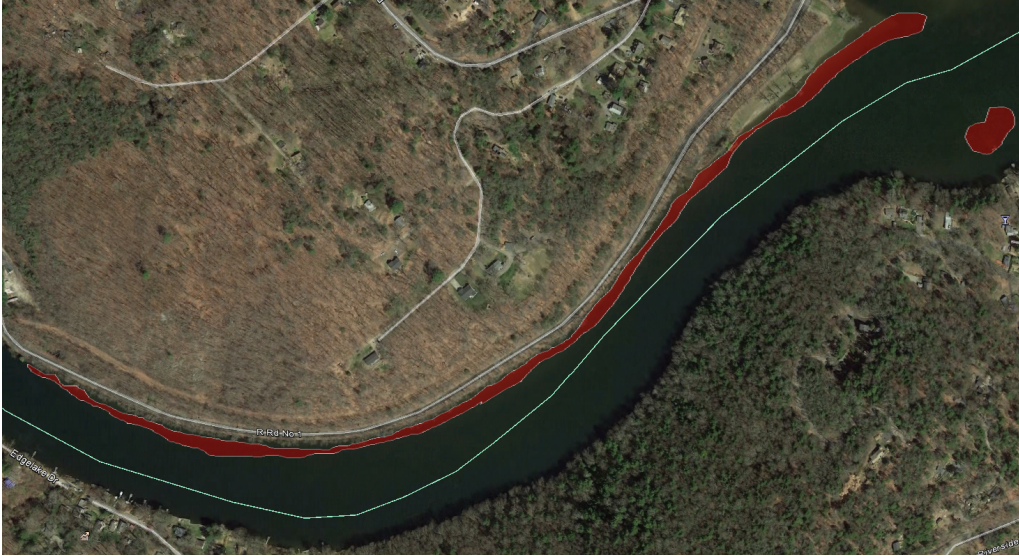
**Map 4: Treatment Area 2 = 4.8 acres**

**Pre-treatment;** Area 2 had dense to very dense curly-leaf pondweed between 70-100% cover as a long continuous band, extending into the cove. This area needs to be treated.

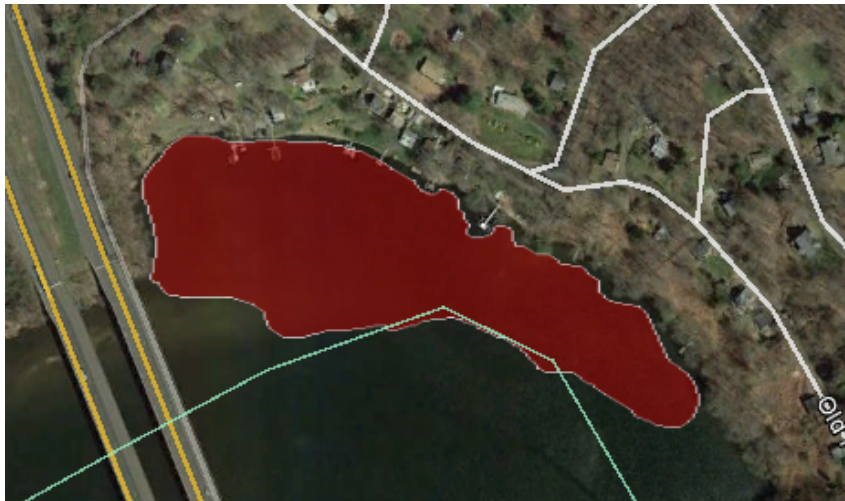
**Map 5: Treatment Area 3 = 9.0 acres**

**Pre-treatment;** Area 3 had extremely dense 100% cover of curly-leaf pondweed throughout. This area needs to be treated.

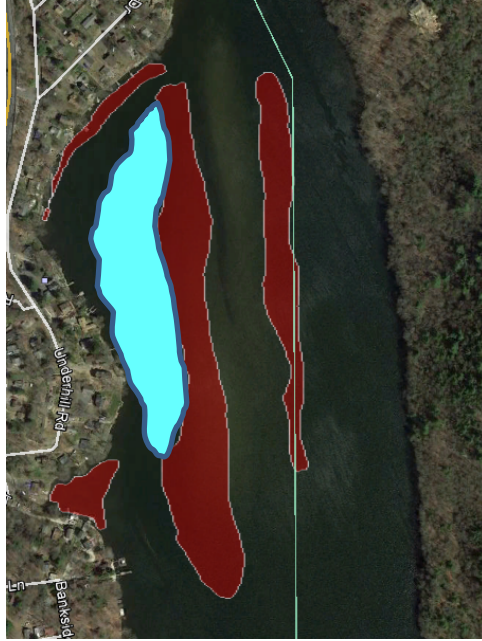
**Map 6: Treatment Area 4 = 13.3 acres**

**Pre-treatment;** Area 4 had moderate to very dense curly-leaf pondweed on both sides of the central sand bar. The treatment area should be expanded to include the area in blue. This area needs to be treated.

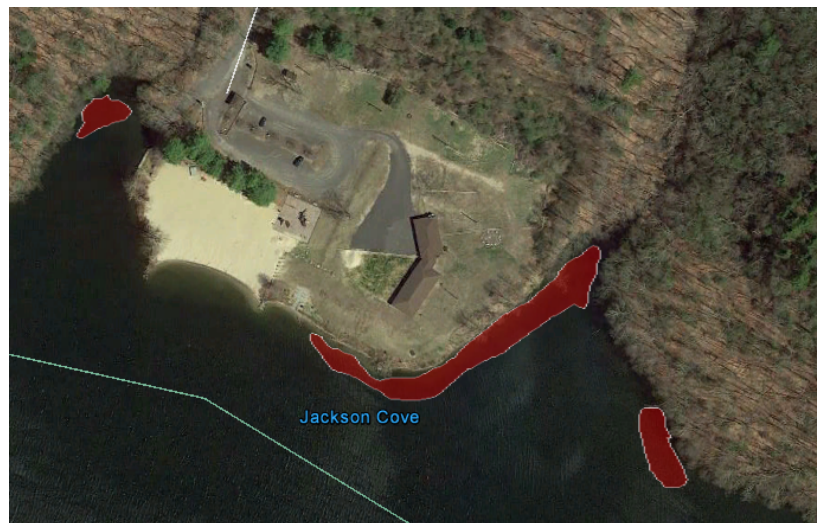
**Map 9: Treatment Area 7 = 0.7 acres**

**Pre-treatment;** Map 9 shows three small treatment areas used in the past. No plants were found along the area called Jackson Cove and to its right. Minor curly-leaf and Eurasian milfoil were found in the small cove to the left in Map 9. This small area should be treated because of the proximity of the boat ramp in this cove.

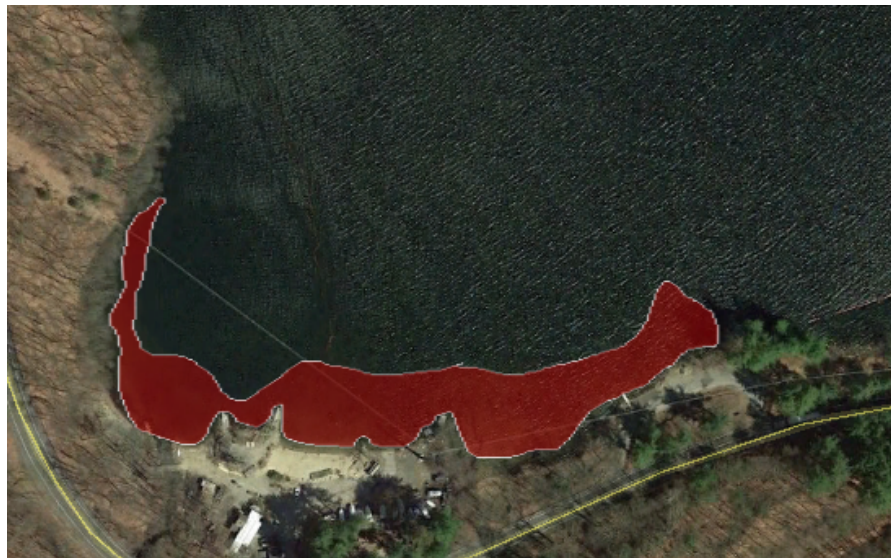
**Map 11: Treatment Area 9 = 2.2 acres**

**Pre-treatment;** there was sparse curly-leaf pondweed adjacent to shore only. This area needs treatment near shore only.
